Manhole Inspection Summary

Manhole # S21E__026MH

Location Address: **1841 MULBERRY-SARAH ANN** Cross Street: **MONROE-KIRBY**

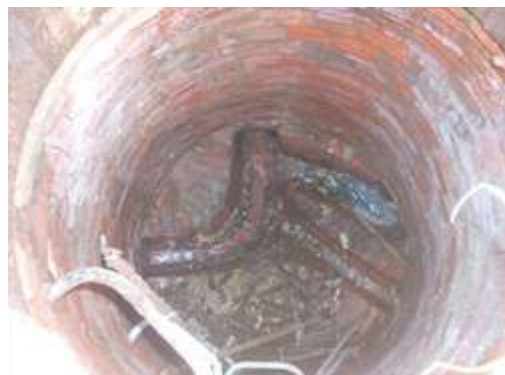
Top View

DEBRIS ON BENCH AND IN CHANNEL

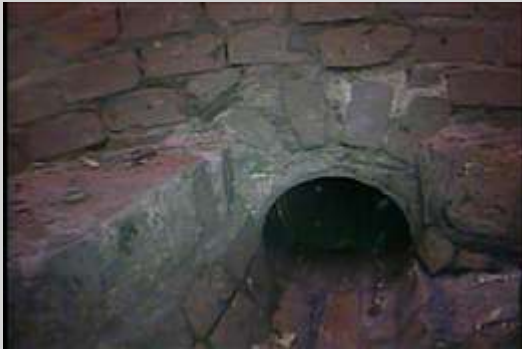
12 O'Clock Outflow

8 in. Circular Gravity Sewer
Pipe Out @ 12 O'Clock

Pipe Height: **8.4** (in.) Rod and Bar (Angled)
Pipe Material: **Clay** ☐ Pipe Lined
Invert Depth: **8.54** (ft.) Flow Characteristics: **Slow**
Deposits: ☒ None ☐ Mud ☐ Sludge ☐ Debris ☐ Grease
Silt Depth: (in.) Deposits Extent:
Infiltration: **None** Pipe Seal Cond: **Sound**

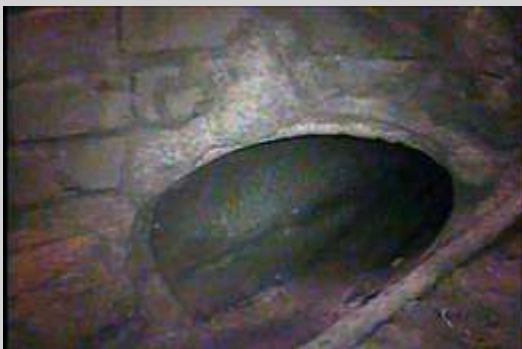
3 O'Clock Inflow

8 in. Circular Gravity Sewer
Pipe In @ 3 O'Clock

Pipe Height: **8.4** (in.) Rod and Bar (Angled)
Pipe Material: **Clay** ☐ Pipe Lined
Invert Depth: **7.83** (ft.) Flow Characteristics: **Slow**
Deposits: ☒ None ☐ Mud ☐ Sludge ☐ Debris ☐ Grease
Silt Depth: (in.) Deposits Extent:
Infiltration: **None** Pipe Seal Cond: **Sound**

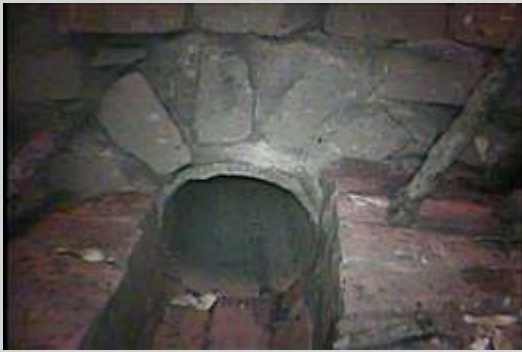
4 O'Clock Inflow

6 in. Circular Gravity Sewer

Pipe In @ 4 O'Clock

Pipe Height: **6** (in.) Rod and Bar (Angled)

Pipe Material: **Clay** ☐ Pipe Lined

Invert Depth: **7.96** (ft.) Flow Characteristics: **Slow**

Deposits: ☒ None ☐ Mud ☐ Sludge ☐ Debris ☐ Grease

Infiltration: **None**

Pipe Seal Cond: **Sound**

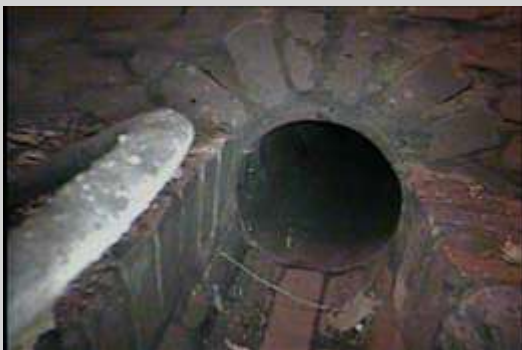
9 O'Clock Inflow

8 in. Circular Gravity Sewer

Pipe In @ 9 O'Clock

Pipe Height: **8.4** (in.) Rod and Bar (Angled)

Pipe Material: **Clay** ☐ Pipe Lined

Invert Depth: **8.07** (ft.) Flow Characteristics: **Slow**

Deposits: ☒ None ☐ Mud ☐ Sludge ☐ Debris ☐ Grease

Infiltration: **None**

Pipe Seal Cond: **Sound**
